Arsenic form and distribution at the historic Alexander gold processing site, West Coast

K. Malloch¹, D. Craw² and D. Trumm³

The Alexander gold mine operated from 1924 to 1943, and was developed in orogenic veins of the Reefton goldfields on the West Coast. Preliminary studies have revealed high arsenic contents and other heavy metals at the Alexander Mine processing site. A roaster was used for a short period of time to liberate gold encapsulated in sulphide minerals, including arsenopyrite. Processing also included amalgamation, cyanidation and precipitation onto zinc plates. Residual processed material was dumped on site. Arsenic values of up to 38 wt% have been recorded by FP-XRF, as well as high zinc value of up 97,000 mg/kg and high Pb, Hg and Sb.

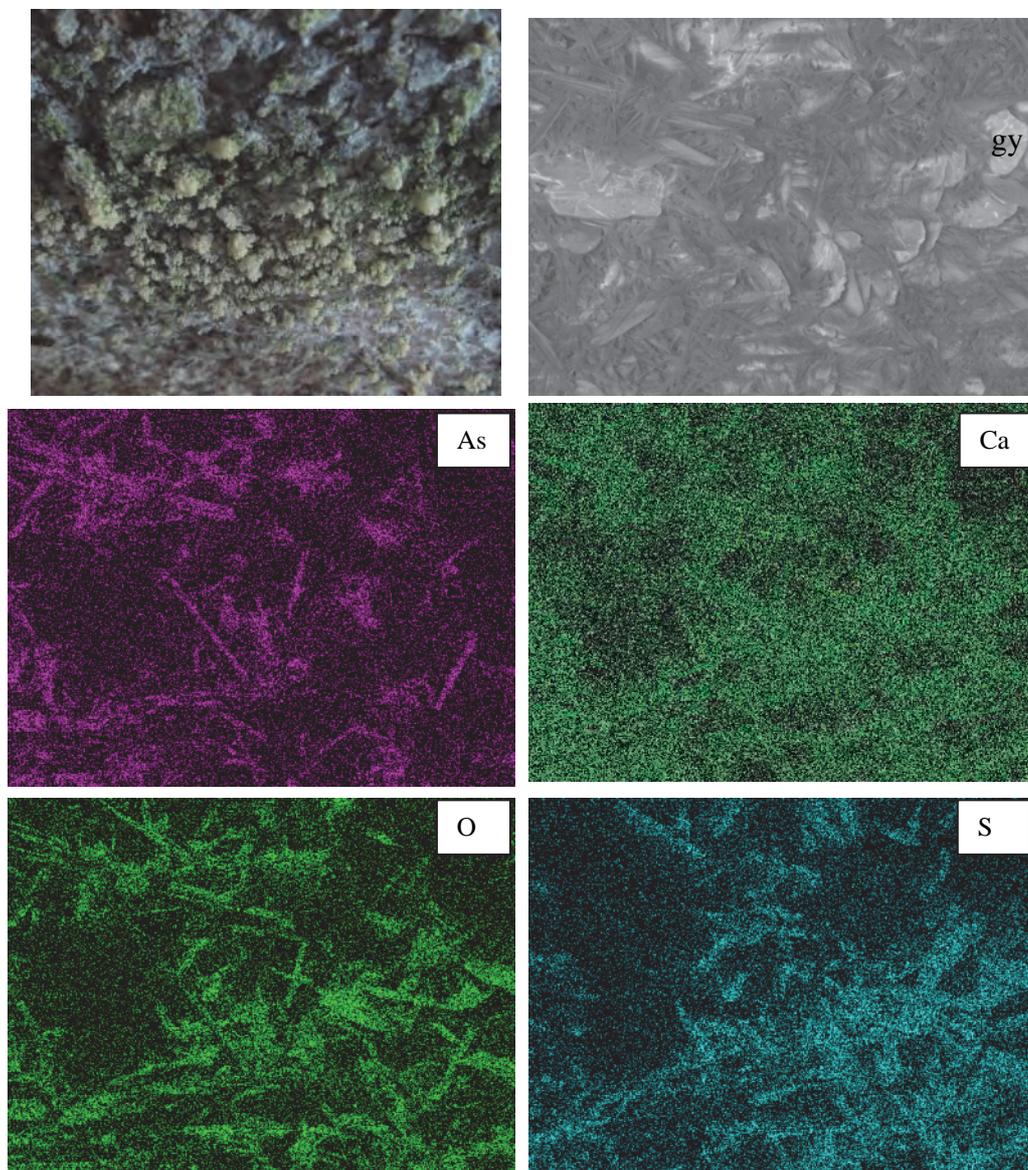
($\text{CaSO}_4 \cdot 2\text{H}_2\text{O}$), which may indicate the addition of lime during roasting (Bothe and Brown, 1999), as well as possible claudetite (As_2O_3) (Fig. 2). Mercury sulphide has been identified from dust on the chimney walls. Paste pH of the material within the roaster and the flue varies from 4.93 to 7.09. The brickwork on the outside of the roaster and the soil immediately surrounding the roaster are low in arsenic (mostly $< 200 \text{ mg/kg}$).

Figure 2. Crystalline growths on the roof of the Edwards Roaster flue. The SEM image shows the presence of a needle-like calcium arsenate mineral and plates of gypsum. Element maps of arsenic (As), calcium (Ca), oxygen (O) and sulphur (S).

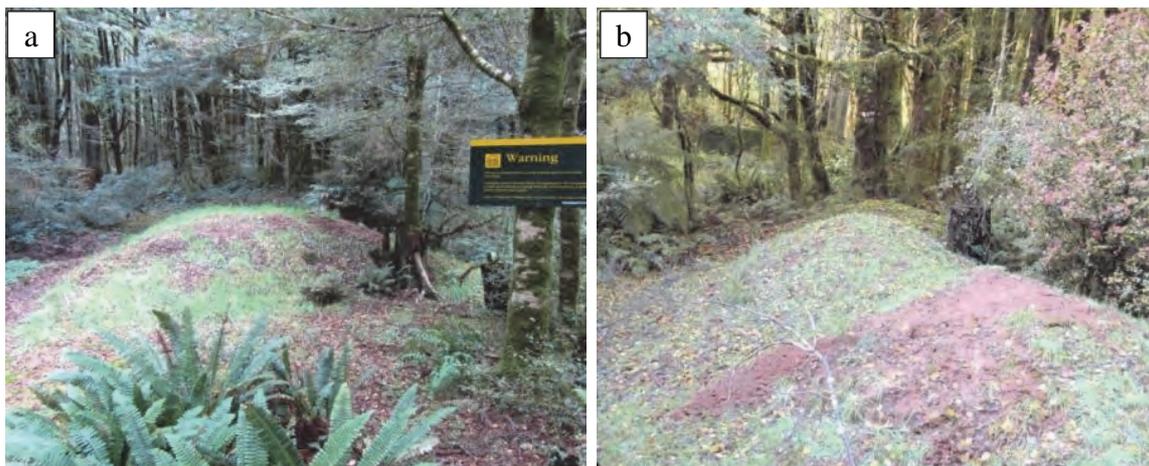
Residual processed material was dumped on the roaster site into three red waste piles comprising approximately 600m^3 (Fig. 3). A 4WD track crosses over, flattens and attenuates the west edge of the westernmost pile. The southernmost pile is immediately adjacent to and above a small creek that cuts through the alluvial terrace. The elongated eastern pile runs sub-parallel to the creek.

Figure 3. Red waste piles at the roaster site. a) red pile that is crossed by the 4WD drive track on the left, b) the long red pile that runs parallel to the creek with exposed waste on top.

The red waste piles have moderate slopes and are covered in grasses and creeping buttercup (*Ranunculus repens*) with minor fern species (Fig. 3). Soils are thin to non-existent with exposed red waste material at the top of the piles. FP-XRF of sapling beech tree leaves and stems (*Nothofagus sp.*) that were growing on the waste pile closest to the creek, indicate elevated levels of As, Fe, Zn, Cu compared to a control sample growing 150 m south of the site. Beech trees also grow in contaminated waste material (up to 100,000 mg/kg As) at the battery site. FP-XRF has been proven to be a useful indicator of contamination in fresh plant material, however, like in-situ soil measurements, the moisture content in the plants will affect the results (Gutiérrez-Ginés et al., 2013). Elevated As, Fe and Zn values are also seen in buttercup and fern samples taken from the red waste piles, but to a lesser extent.

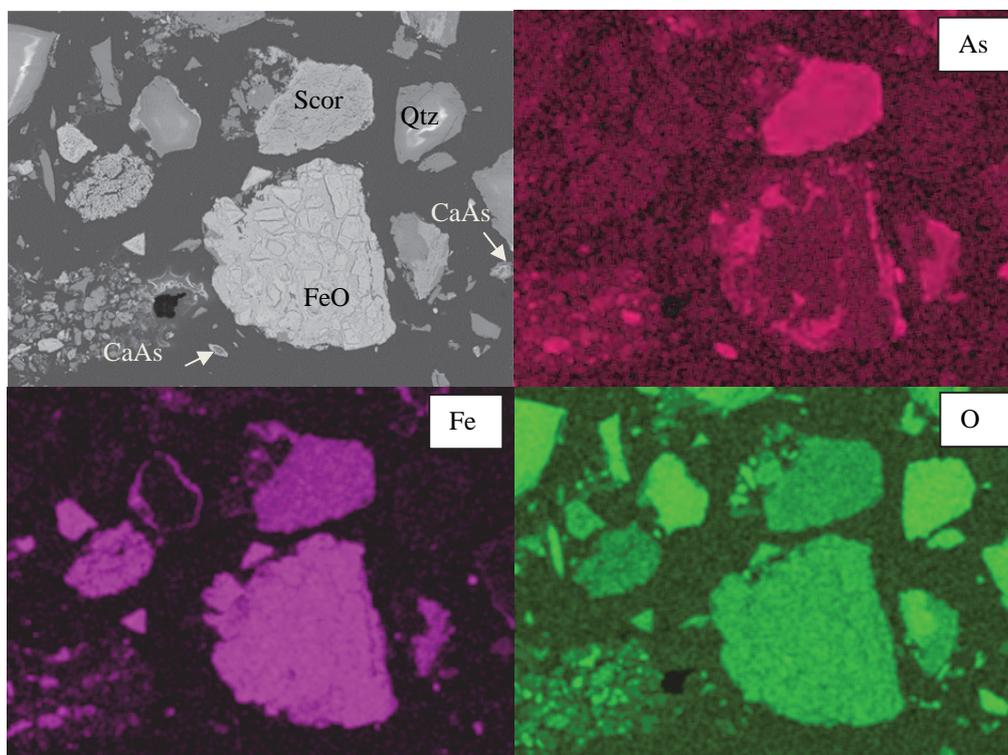
The piles are completely oxidised and consist of mostly quartz and iron oxide with minor clay aluminosilicates and scorodite, a hydrated iron arsenate mineral ($\text{FeAsO}_4 \cdot 2\text{H}_2\text{O}$) (Fig. 4). There is also a calcium arsenate mineral present but the grain size is small ($< 20\mu\text{m}$). FP-XRF values of arsenic up to 35,000 mg/kg (sample dried and milled) have been recorded in the red piles. Paste pH of the red piles varies from 5.27 to 6.41. Scorodite stability, and therefore arsenic mobility, is controlled by the acidic and oxidised nature of the red waste piles. Arsenic solubility from scorodite is high in strongly acidic or alkaline pH soils (Krause and Ettel, 1989, Fujita et al., 2011). The red piles are homogenous with depth, with a sharp transition to clayey silts then alluvial sands over 10-15 cm immediately above the river terrace boulders. Arsenic is elevated in the alluvials ($< 2,000$ mg/kg), although some of this arsenic will be from contamination during augering.

Figure 4. SEM image of the red waste pile material (AMR10), with scorodite (Scor), quartz (Qtz), iron oxides (FeO) and a calcium arsenate mineral (CaAs) and element maps for arsenic (As), iron (Fe) and oxygen (O).

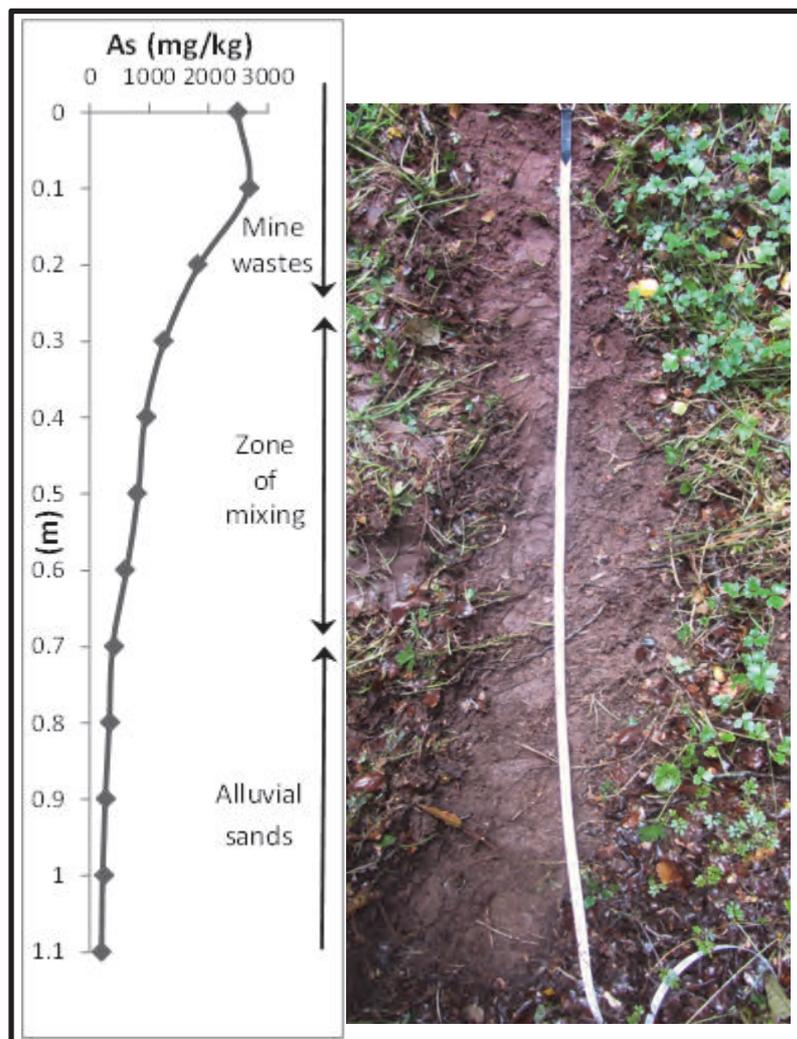
Arsenic contamination of the site, excluding the Edwards Roaster, is very easily identified visually by the colour of the soil. Contaminated waste is a bright brick red colour, while the alluvial sands are a light yellowish brown colour. A lateral profile across the edge of one of the red piles and into the soils of the alluvial sands shows a gradual reduction of the red colour, with associated reduction of arsenic contamination as well as Fe, Pb and Zn values (Fig. 5). The correlation of soil colour to arsenic contamination could be used as a guide to allow for a quick clean-up of the site which can be later checked with FP-XRF when the remediation is complete.

Figure 5. Lateral section from the side of one of the red waste piles into the alluvial sand soils.

FP-XRF proved to be a quick and reliable field method for showing relative contamination but should not solely be relied upon for exact values. Unique to the Alexander site, the colour of the soil can be used as a guide to allow a quick clean-up of the roaster site. FP-XRF can also be used to give an indication of contamination uptake by plants.

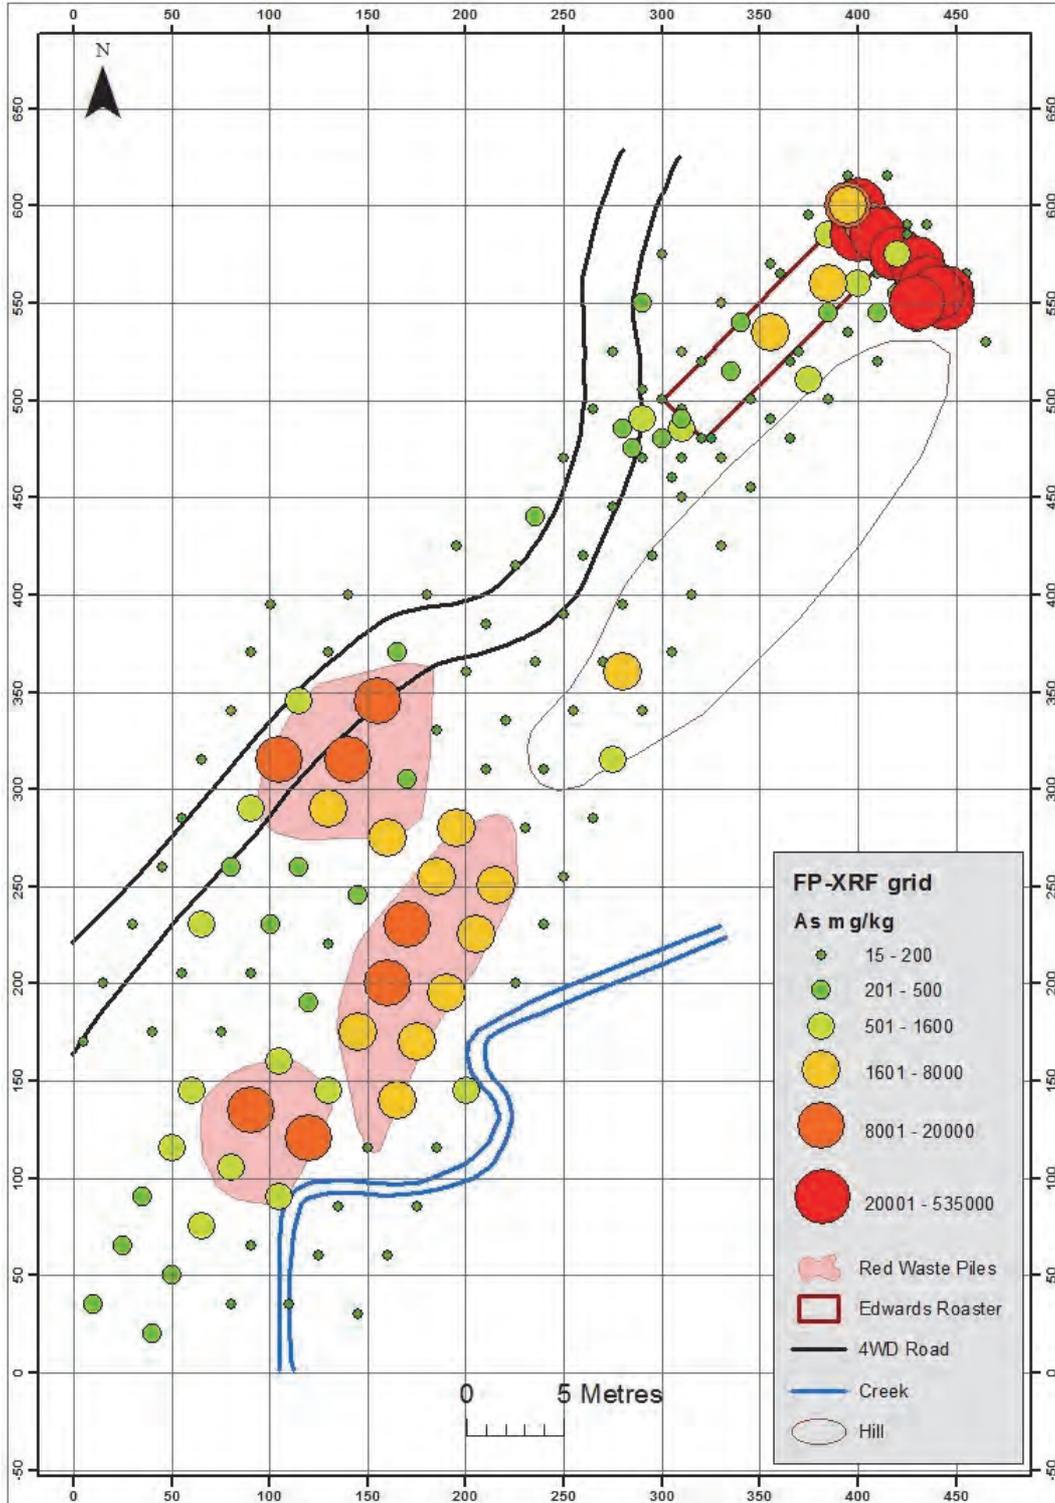
A FP-XRF grid was completed using an Innov-X machine in soil mode with a 30 second count time. A 3 m grid spacing was done over the roaster site, with a 1 m grid over and around the Edwards Roaster, including spot checks of the inside and outside of the brickwork (Fig. 6). The grid was completed to define the extent of the arsenic contamination as well as to identify heavy metal contamination.

The Edwards Roaster flue has the highest arsenic values on the site. The flue and roaster have extremely high As (up to 530,000 mg/kg) and elevated Hg (up to 1,400 mg/kg), Sb (600 mg/kg), W (up to 600 mg/kg), Zn (up to 1,800 mg/kg) and Pb (up to 900 mg/kg). The Fe

(up to 180,000 mg/kg) and Ti (up to 1,600 mg/kg) contents are a lot lower than that of the red piles. For the 3 m site grid, arsenic contamination was highest in the red piles with values of up to 13,000 mg/kg. The red piles had the highest Fe (up to 385,000 mg/kg), Ti (up to 6,900 mg/kg) as well as elevated Pb (up to 350 mg/kg) and Zn (2,300 mg/kg). There is a trace of Hg, Sb and W associated with the higher arsenic values in the red piles.

Figure 6. FP-XRF grid over the roaster site, showing arsenic values, with high values in the three red waste piles and flue of the Edwards Roaster.

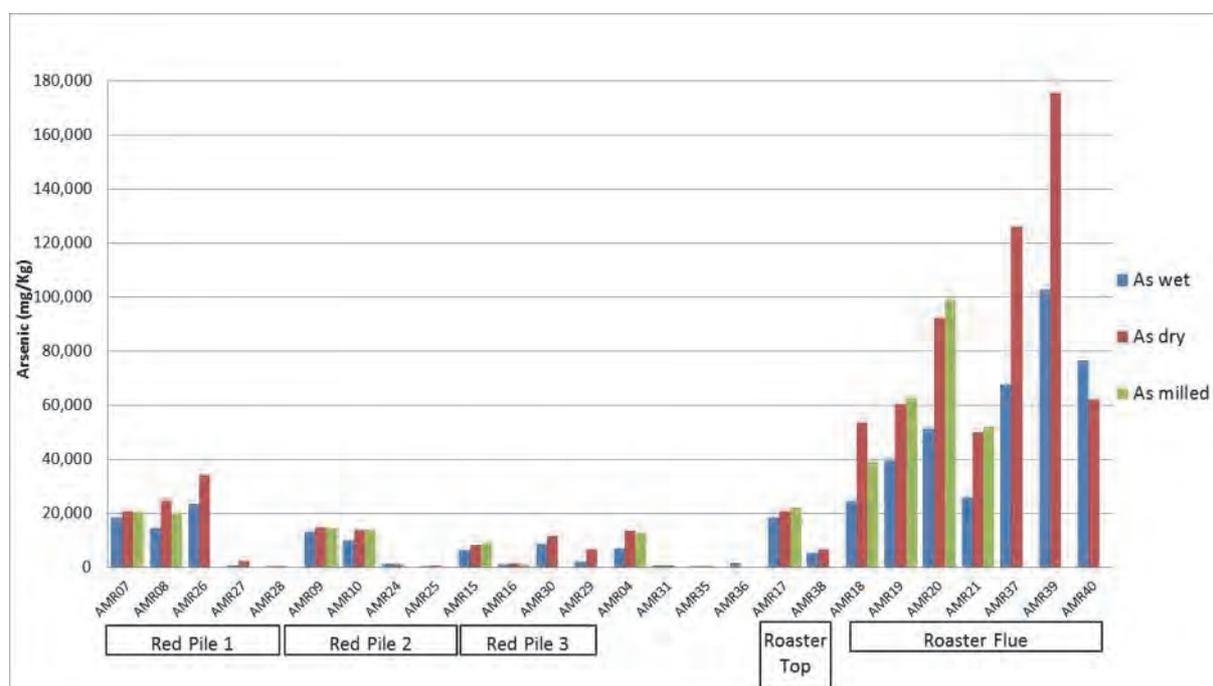
Moisture content and sample homogeneity can affect the results from the FP-XRF. A FP-XRF will give relatively good results for samples with 5-20 % moisture content, anything with a moisture content over 20% will be under-estimated (Laiho and Perämäki, 2005). The roaster site is covered in secondary Beech (*Nothofagus sp.*) growth forest, protecting the site from evaporation (Fig. 3). There is often permanent standing water in depressions in the 4WD road, including where the road crosses over one of the red piles. Representative samples were taken of the red piles at surface and at depth, in contaminated alluvials, road samples and material within the Edwards Roaster, over a range of arsenic values and moisture contents. Moisture contents ranged from 10-42 %, with over half of the samples having moisture contents greater than 20 %. Preliminary results show that there is a greater variation in arsenic values between wet and dried sample than between dried and milled samples, especially for saturated samples with greater than 20,000 mg/kg As (Fig. 7). Samples will be sent off to the laboratory for XRF, in order to calibrate the FP-XRF grid.

Figure 7. Arsenic values of roaster site samples showing the difference in FP-XRF arsenic values between wet, dried, and dried and milled samples. Note that some samples are in the process of being milled.

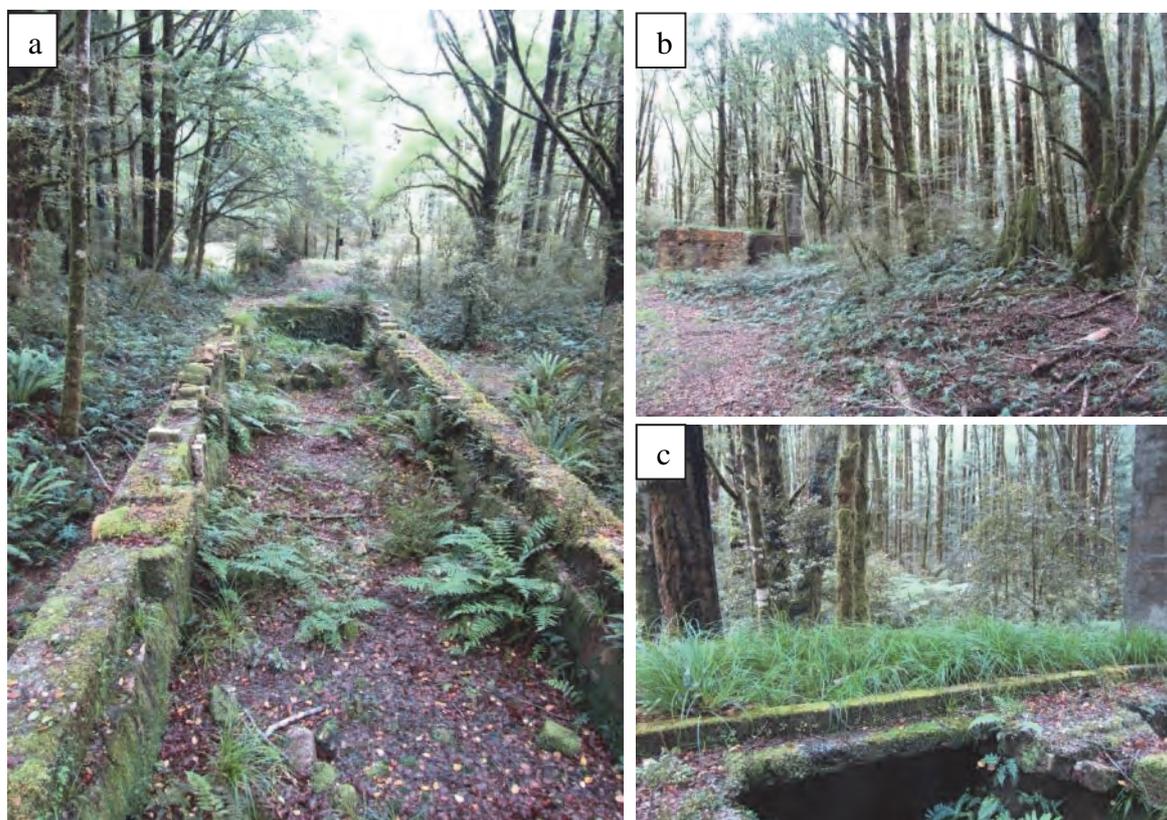
The outside brickwork of the Edwards Roaster was covered in a thick layer of moss which has since been sprayed by DOC in preparation for site clean-up. The inside of the roaster, which is exposed to the environment, is sparsely covered in ferns, mosses, grasses and sapling trees including Horopito (*Pseudowintera colorata*) (Fig. 8). FP-XRF of sapling Horopito leaves and stems show elevated As, Fe and Zn. Native hook grass (*Uncinia uncinata*) grows on top of the flue in arsenic contaminated soils (up to 9,500 mg/kg) with high Zn (up to 1,800 mg/kg). There is no vegetation growing on the inside of the flue.

Figure 8. Alexander roaster site. a) Looking south from the top of the Edwards Roaster, with sparse vegetation growing inside the roaster, mainly ferns and mosses with Horopito (*Pseudowintera colorata*) saplings. b) Secondary regrowth forest, predominantly Beech (*Nothofagus sp.*), with 4WD track and roaster on the left c) Hook grass (*Uncinia uncinata*) growing on top of the flue.
